**POLICY MEMORANDUM xx**  
**(0x-2023)**

SUBJECT: Determination of the Downstream Toe of Dam for Impoundment Facilities

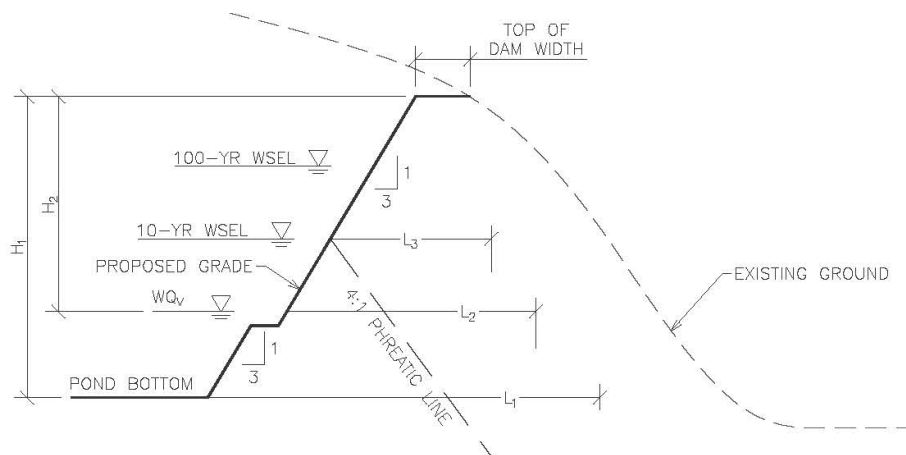
**Figure 1: An Excavated Facility**  
(Core and cutoff trench not typical for excavated facilities)

Pursuant to MD-378, and MDE policies, embankments meeting a specific set of criteria may be considered excavated. The horizontal projection defined by  $10H+20=L$ , where 'H' is the height from the pond bottom to the *constructed* top of the dam. An excavated facility must also demonstrate that the longitudinal gradient **on the downgrade section of all cross-sections – perpendicular to the centerline of the embankment – shall not exceed 10% within the projection of 'L'.**

**Where Submerged Gravel Wetlands are proposed, the determination of the height of embankment shall begin at the *constructed* top of dam to the bottom of the gravel media, or to the lowest point of excavation. This height of dam shall be measured form the top of the *compacted clay liner*, if one is proposed.**

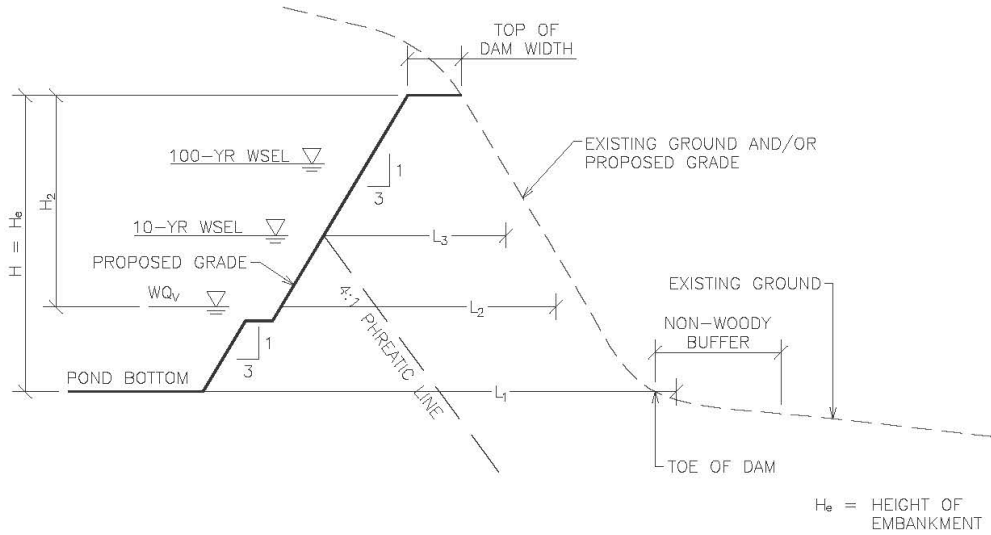
**Figure 2: An Embankment Facility**  
(Core and cutoff trench not shown for clarity)

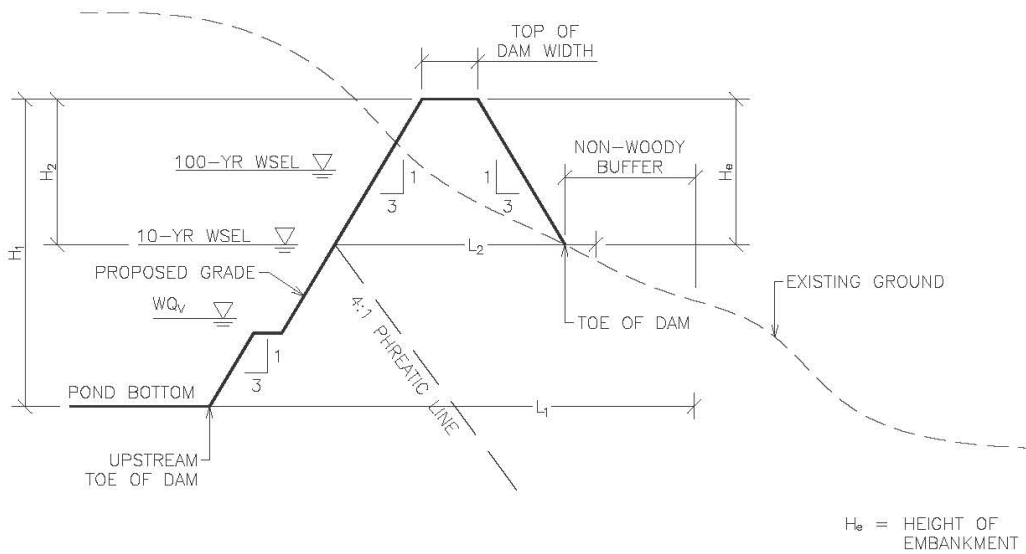
**Figure 3: A Hybrid Embankment Dam Section -**  
(Core and cutoff trench not shown for clarity)

The section of the hybrid dam considered as excavated in **Figure 3** must also demonstrate that the longitudinal gradient at all cross-sections perpendicular to the center line of the top of dam within the projection of 'L' is less than 10%.

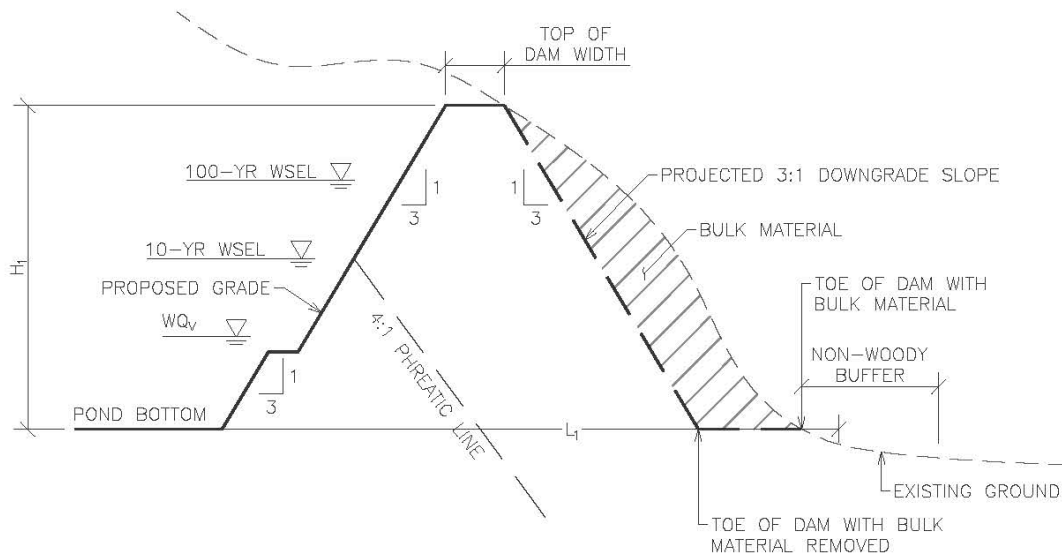
**Figure 4: Embankment Dam Section with Bulk Material**  
(Core and cutoff trench not shown for clarity)

The principles illustrated in the previous figures are likewise applied to facilities adjacent to steep slopes. Steep slopes are defined as longitudinal slopes of 15% or greater.
