**POLICY MEMORANDUM xx**  
**(0x-2023)**

SUBJECT: Determination of the Downstream Toe of Dam for Impoundment Facilities

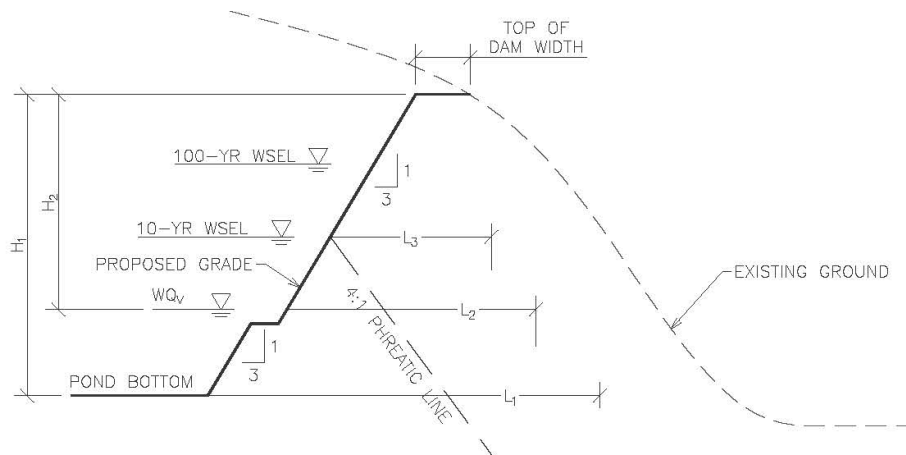
Pursuant to MD-378, embankments meeting a specific set of criteria may be considered excavated. The horizontal projection defined by  $10H+20=L$ , where 'H' is the height from the pond bottom to the top of the dam, and the downstream are ground slope are exemplified below. It should be noted, however, that excavated facilities are not exempt from small pond review and approval as noted in MD-378.

**Figure 1: An Excavated Facility**  
(Core and cutoff trench not typical for excavated facilities)

An excavated facility must also demonstrate that the longitudinal gradient at all cross-sections perpendicular to the center line of the top of dam within the projection of 'L' is less than 10%.

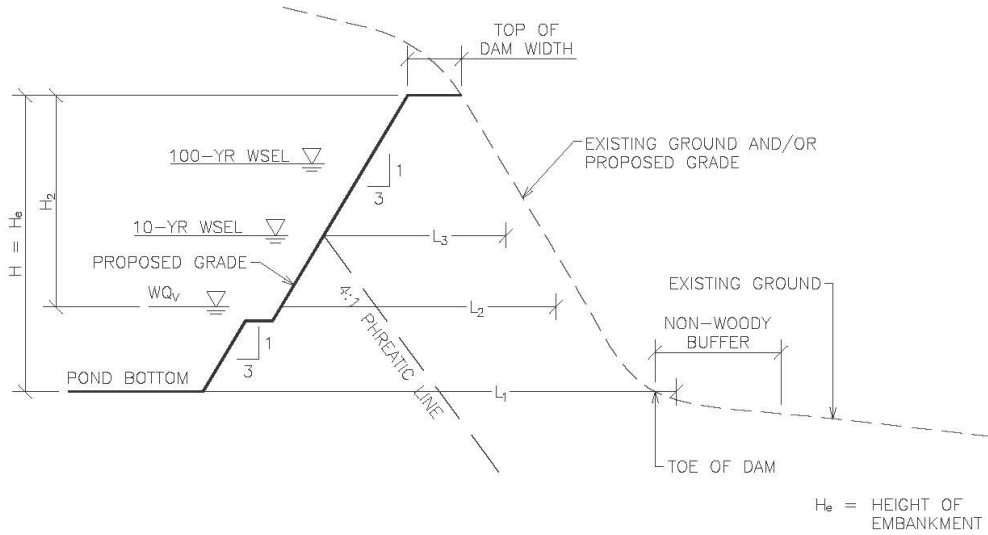
**Figure 2: An Embankment Facility**  
(Core and cutoff trench not shown for clarity)

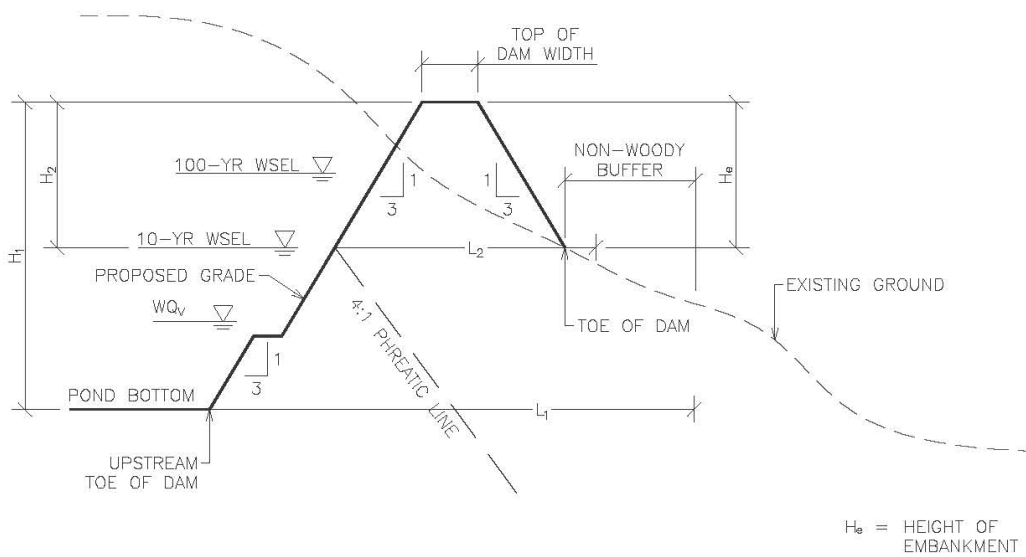
**Figure 3: A Hybrid Embankment Dam Section -**  
(Core and cutoff trench not shown for clarity)

The section of the hybrid dam considered as excavated in **Figure 3** must also demonstrate that the longitudinal gradient at all cross-sections perpendicular to the center line of the top of dam within the projection of 'L' is less than 10%.
