Urban Conservation Accomplishments - 2011

Urban Statistics

Local Banks Yield High Interest

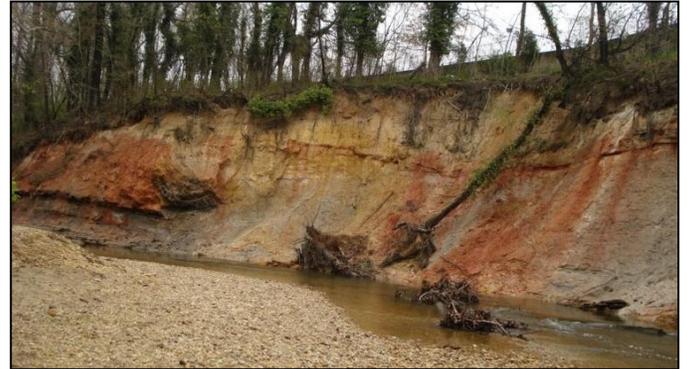
Stream bank failure scarp near Route 1, College Park

The erosion of streambanks is a natural process of a flowing stream over time. However it becomes detrimental when accelerated by land development or lack of vegetation. Over time this will affect the integrity of uphill slopes.

The Department of Environmental Resources has identified and submitted several sediment control plans for streams within the County that have critically eroded banks and slopes. At most sites, the slopes are at risk of failure or are currently failing. The restoration process employs several natural techniques to repair the stream banks along with mechanical stabilization for toe of slope stabilization. Some of the methods used for stream restoration are: cross vanes (lines of stone placed at an angle to direct water to the center of the stream), step pools (rocks placed to form a pool and dissipate the water flow), root wads (trunks of roots placed for anchoring banks and providing aquatic habitat), live fascines (live branches bundled together and planted along stream banks), and imbricated rip rap (large rocks placed to form a wall and stabilize embankment soils).

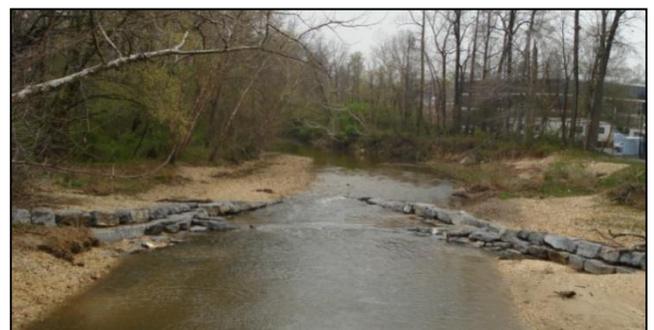
Cross vane focuses flow toward the stream's center
